Technical Note N-1291

ZINC-RICH COATINGS FOR ALUMINUM IN SEAWATER

NAVAL CIVIL ENGINEERING LABORATORY
Port Hueneme, California 93043

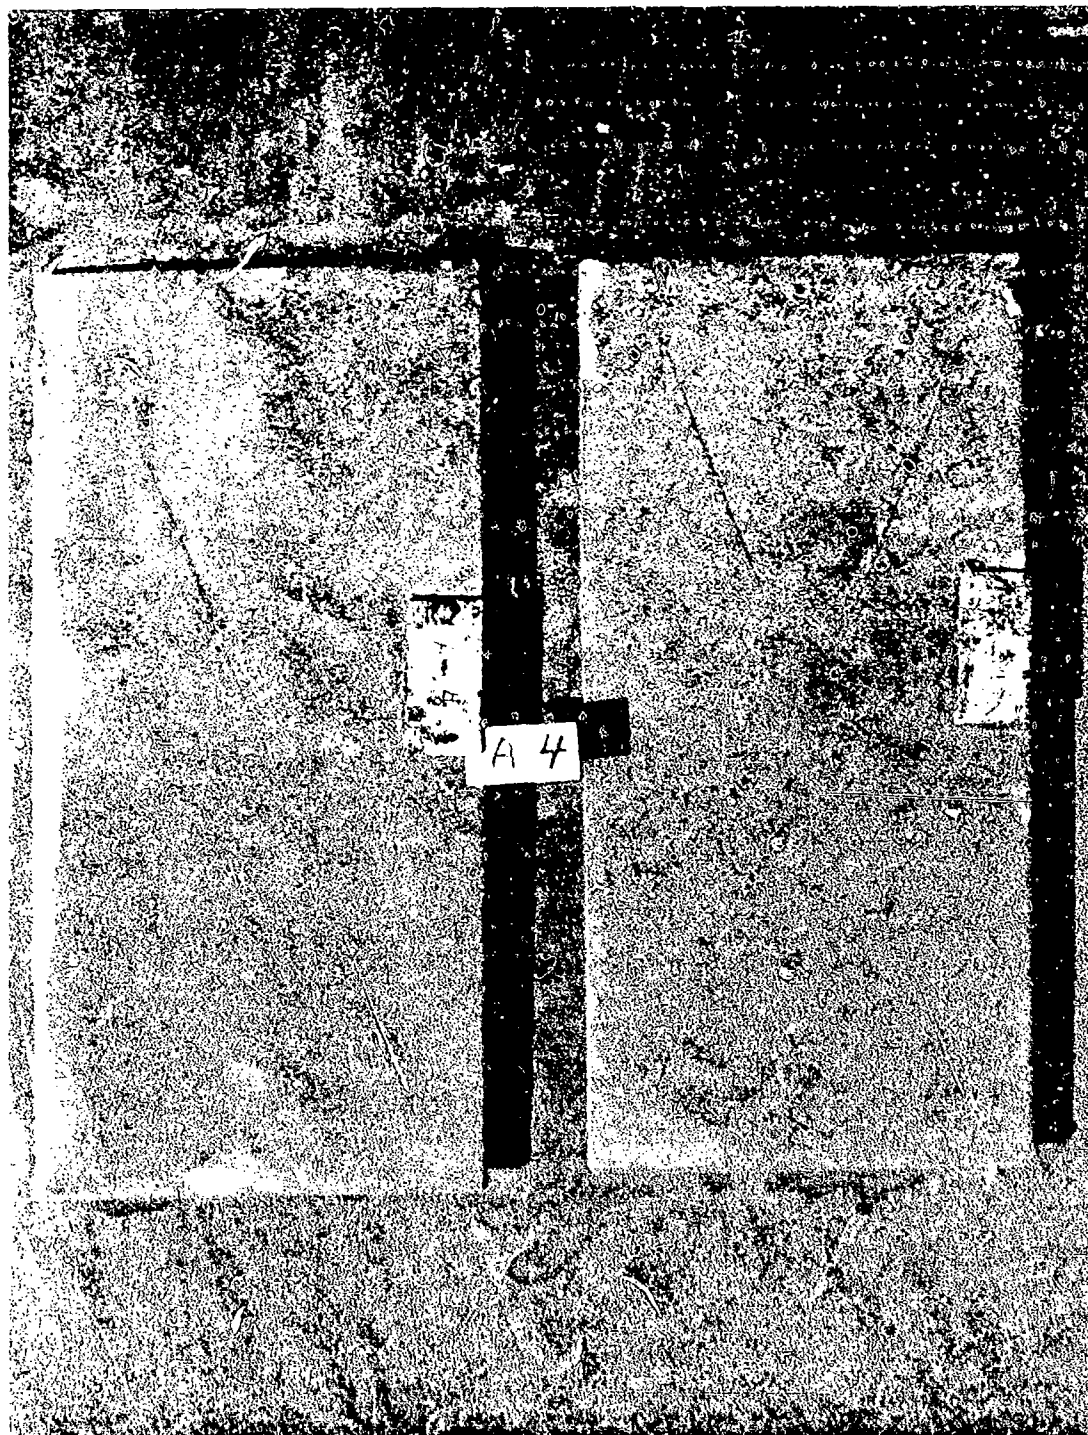
The best protection from the zinc-rich coatings without topcoats was found from the System A-4, Rust Ban 191, a self-curing zinc inorganic silicate at a thickness of 7.0 mils (0.007 inch). Although the protection after 3 years of immersed exposure was excellent the remaining coating was very thin, Figure 3. System A-1 Carbo Zinc 11, System A-5, zinc-rich saran and System A-11, zinc-rich chlorinated rubber, were

Figure 3. Self-curing zinc inorganic silicate, Rust Ban 191, (7.0 mils) after 3 years exposure in Port Hueneme Harbor.

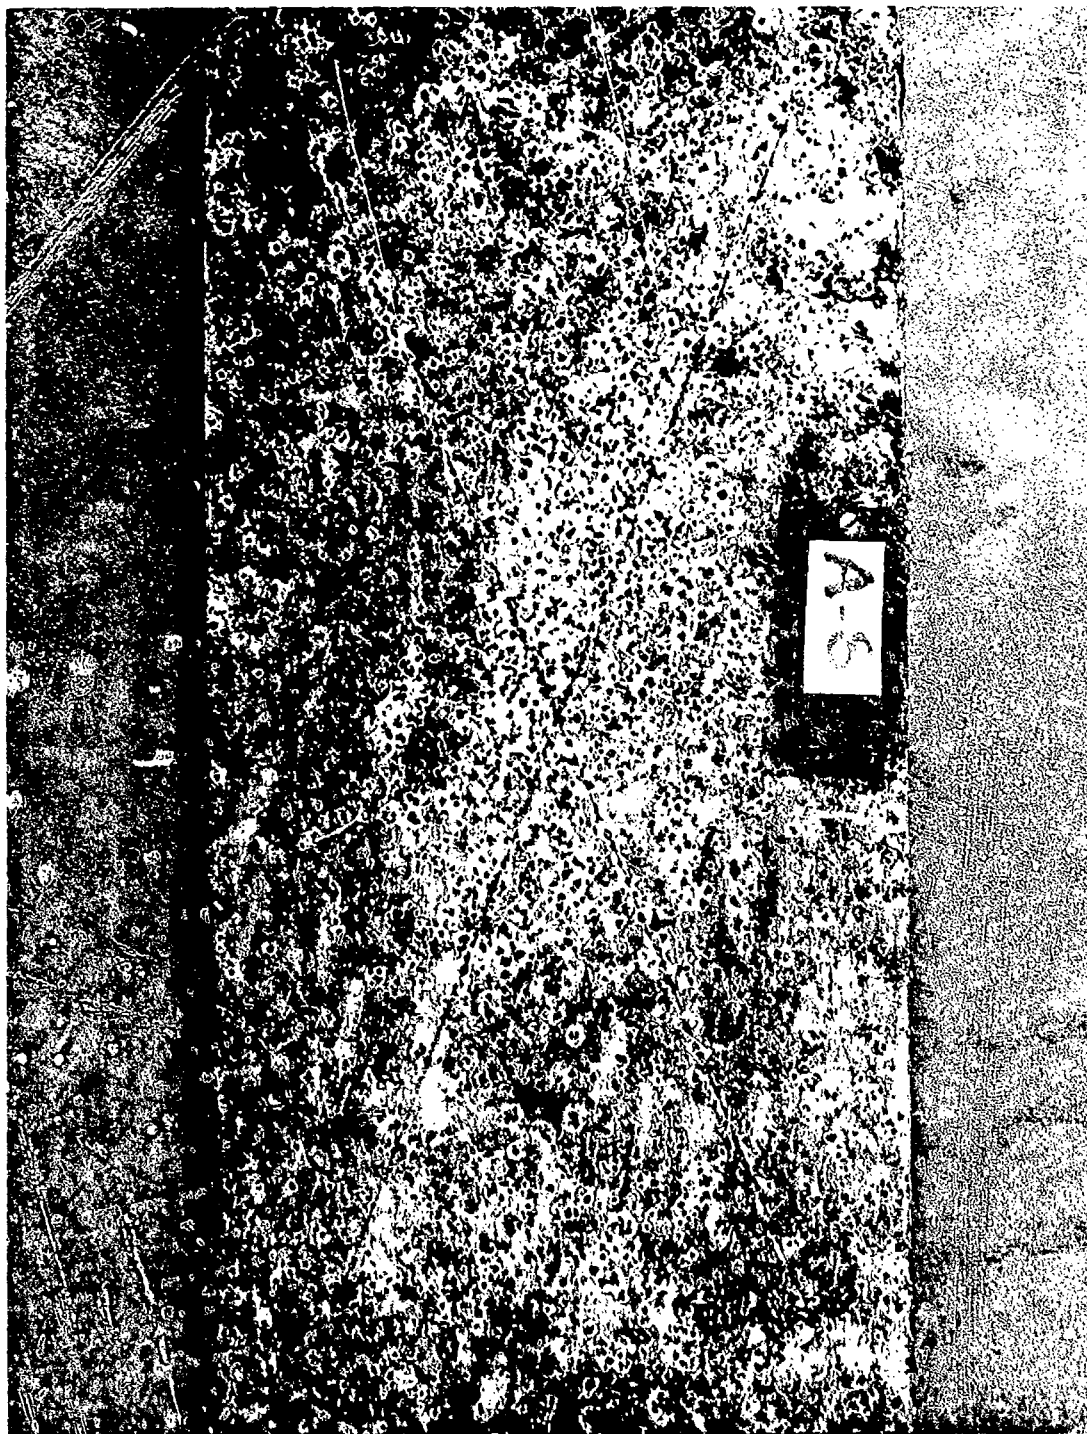
The Alodine 1200S anodizing treatment (Figure 4) without a topcoat, System A-8, failed to protect the aluminum panels in less than 1 year of exposure in Port Hueneme Harbor.

Figure 4. Alodine 1200S anodized aluminum panel, pitted and corroded after 2 years in Port Hueneme Harbor.

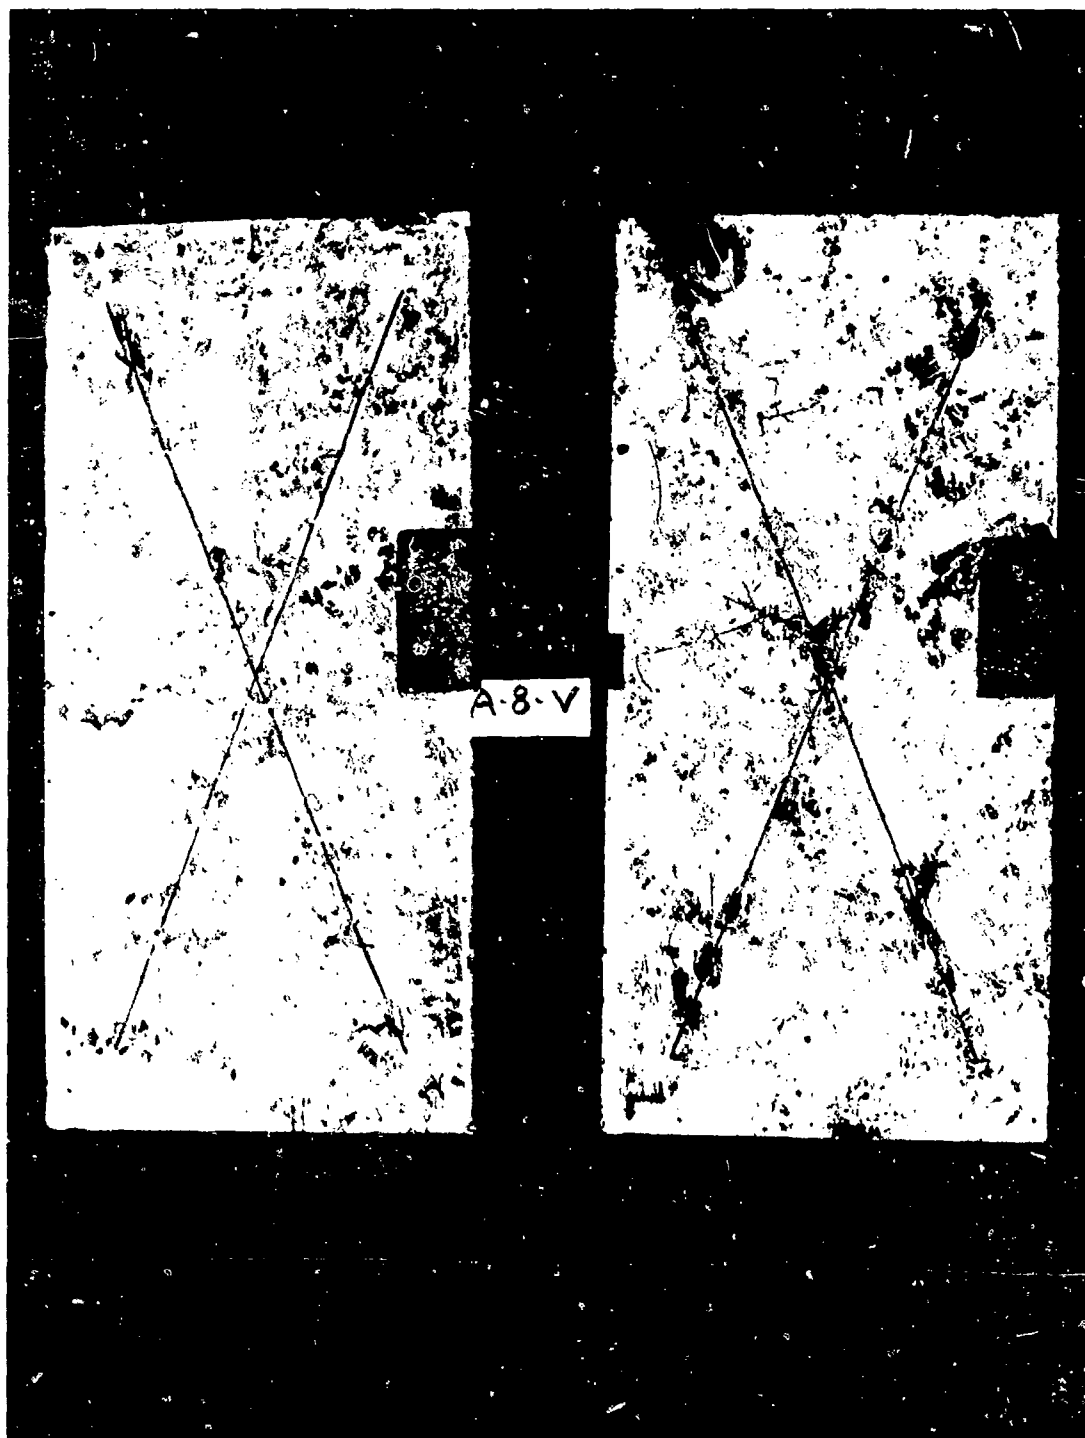
Good protection from a vinyl topcoat system was found when applied over the following substrates: zinc inorganic silicates Dimetecote 3, System A-2-V; Rust Ban 190, System A-3-V; Rust Ban 191, System A-4-V; and the Alodine 1200S anodizing treatment, System A-8-V (Figure 5); as well as the saran coating System A-5-S with the saran topcoat. The primary cause of coating deterioration was from blistering along the scribe which varied from a few blisters to a rating of medium. Except for System A-4-V, no blistering had occurred on the un-scribed side of these panels. The vinyl system over Carbo Zinc II, System A-1-V was giving only fair protection along the scribe after 3 years of exposure in Port Hueneme Harbor, and as with System A-4-V, blisters had formed on the un-scribed side of the panels and could impair long term bonding. The vinyl over the sandblasted aluminum panels, System A-9-V, had failed by the end of the 3 years. When applied over the aluminum after only a solvent wash, System A-10-V, failure of the vinyl system occurred in less than 2 years. Thus the sandblasted surface preparation was significantly better than a solvent wash.

Figure 5. The specification vinyl system over Alodine 1200S after 3 years in Port Hueneme Harbor.

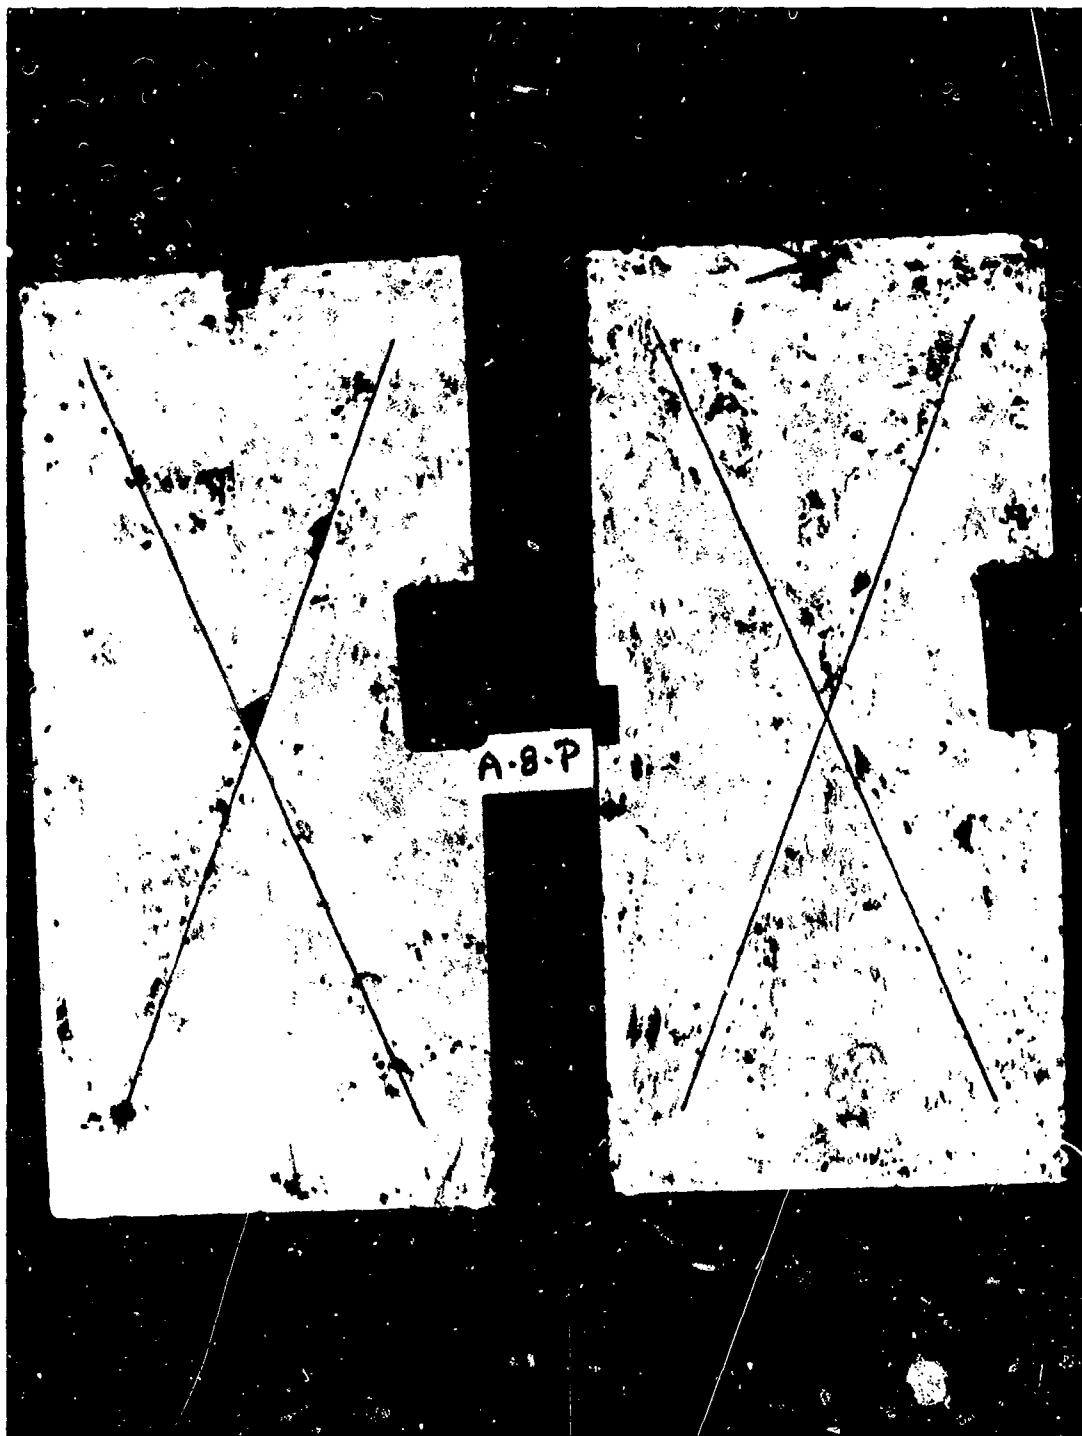
Slightly the best protection given by the epoxy topcoat systems was over a self-curing zinc inorganic silicate, Rust Ban 190, System A-3-P, Figure 6 and over the Alodine 1200S, System A-8-E and System A-8-P, Figure 7. The protection was excellent on both sides of these panels. Only a few blisters were found along the scribe of System A-3-P with no undercutting. The following epoxy topcoat systems gave good to excellent protection during the 3 years of exposure, Systems A-2-P, A-3-E, A-4-E and A-6-E. The latter system, A-6-E, was a zinc rich epoxy primer with an epoxy topcoat system, Figure 8. Only medium

Figure 7. Plasite epoxy over Alodine 1200S, exposed 3 years in Port Hueneme Harbor.

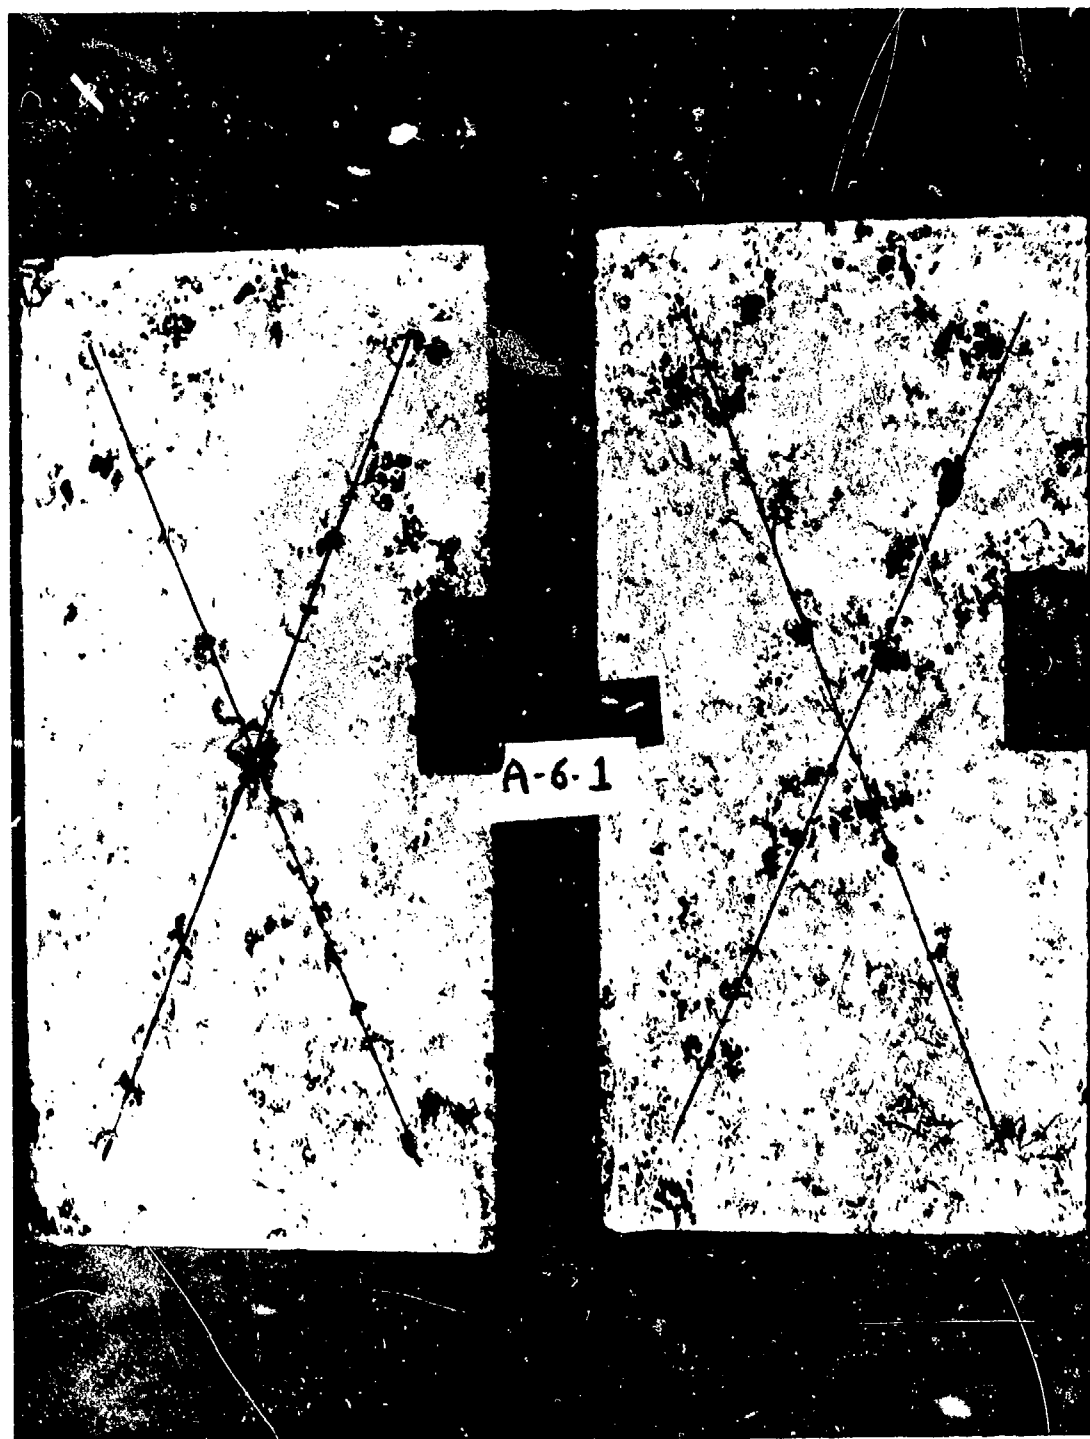
Figure 8. Zinc rich epoxy primer EX6662 and epoxy topcoat after 3 years in Port Hueneme Harbor.

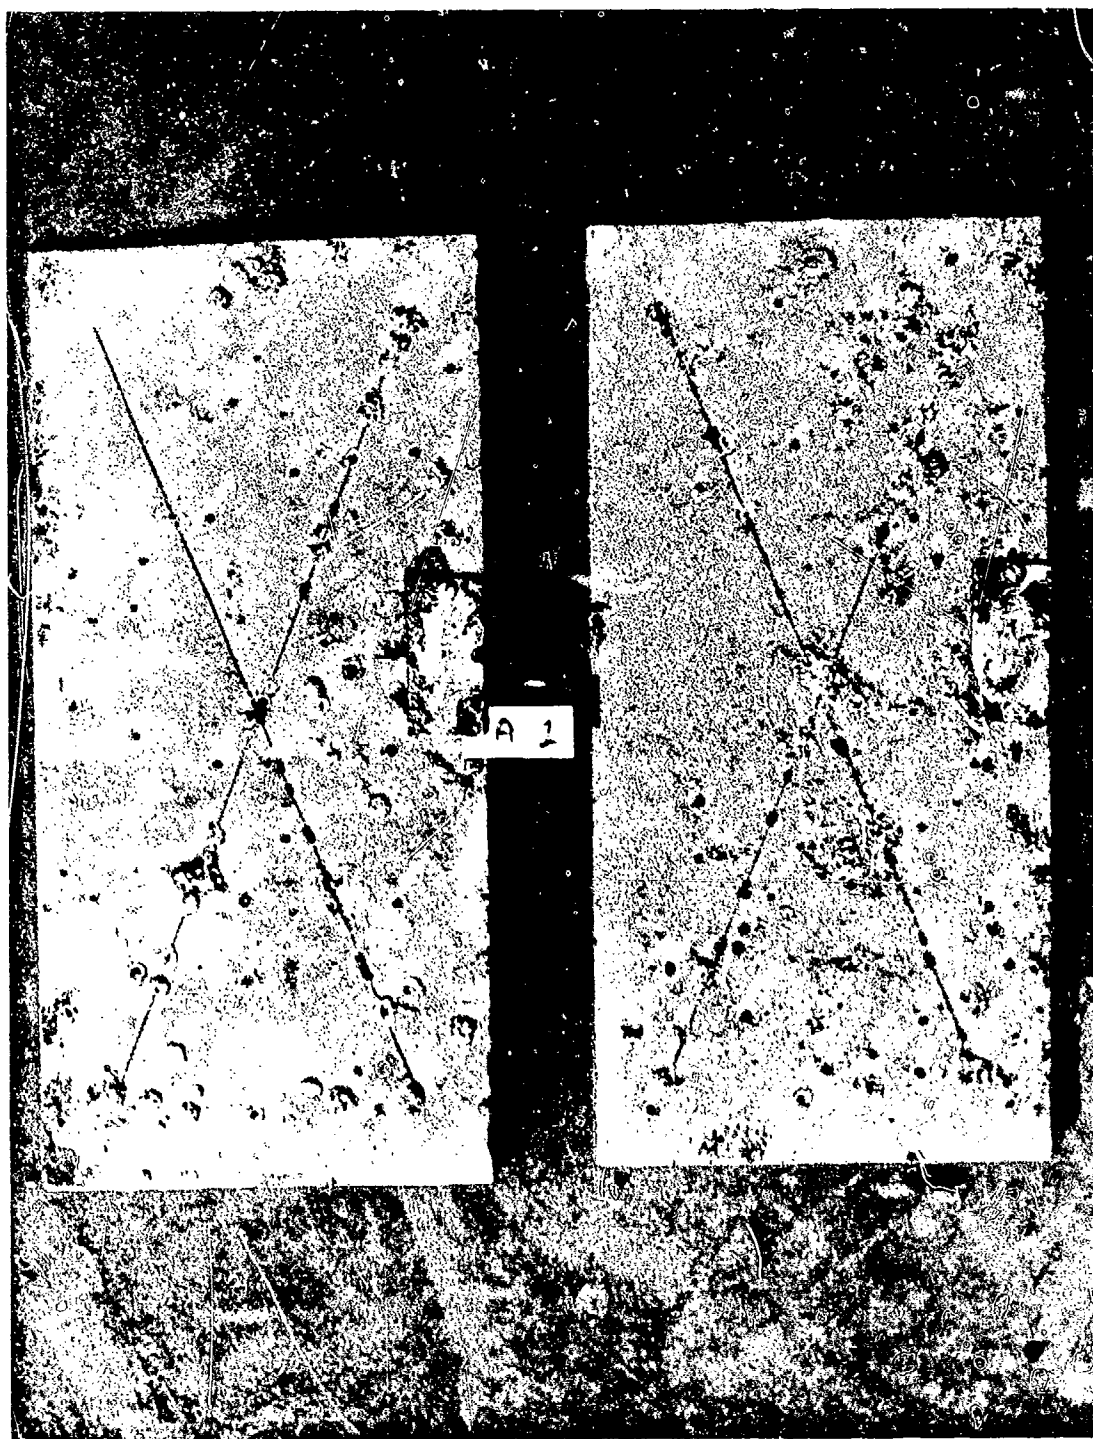
The following epoxy topcoats were near failure after the 3 year exposure period in Port Hueneme Harbor; Systems A-1-E, A-2-E, A-9-E and A-11-E. System A-9-E had a sandblasted surface preparation only, and System A-11-E had a zinc-rich chlorinated rubber primer. Medium to dense blistering was observed along the scribes. Dense blistering indicating loss of bond had occurred in the un-scribed areas of System A-1-E, Carbo Zinc 11 with HB 190 topcoat, Figure 9.

Figure 9. General blistering of the epoxy topcoat over Carbo Zinc 11 during 3 years in Port Hueneme Harbor.

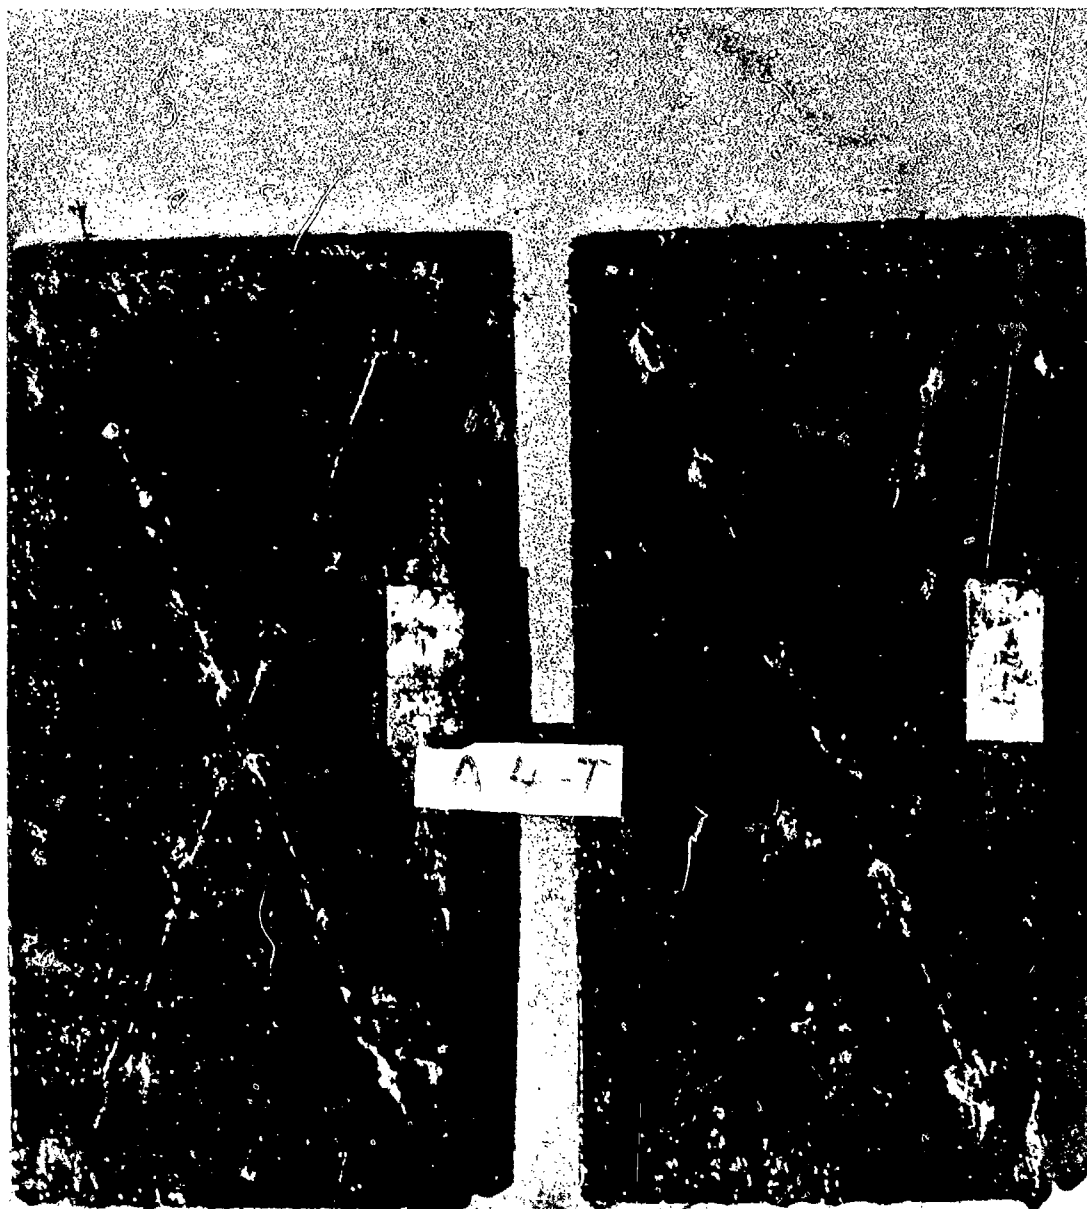
The coal-tar epoxy topcoat gave good to excellent protection for 3 years when applied over the zinc inorganic silicates of System A-4-T (Figure 10), Rust Ban 191 and System A-2-T, Dimetecote #3, as well as when applied over the Alodine 1200S anodizing treatment, System A-8-T. Only a few blisters were observed along the scribe and none on the un-scribed surfaces. Although the coal-tar epoxy was giving good protection over the zinc-rich epoxy System A-6-T and the zinc inorganic silicate Systems A-1-T, Carbo Zinc 11, and A-3-T Rust Ban 190, a few blisters along the scribe had caused flaking of the coal-tar epoxy from the primer. No blisters were observed on the un-scribed surfaces. The coal-tar epoxy topcoat over zinc inorganic silicate, System A-1-T, was giving good protection after 3 years of exposure in Port Hueneme Harbor. Blistering and undercutting along the scribe as well as blistering over the un-scribed surfaces, indicated a lessening of the protective potential for this system. The coal-tar epoxy over the zinc-rich epoxy primer Rust Ban EX6662, System A-6-T, was giving good protection after 3 years of exposure with no blistering over the un-scribed surfaces; however, considerable undercutting was initiated by a few blisters along the scribe.

Figure 10. Coal Tar Epoxy over a zinc inorganic silicate (Rust Ban 191) after 3 years in Port Hueneme Harbor.

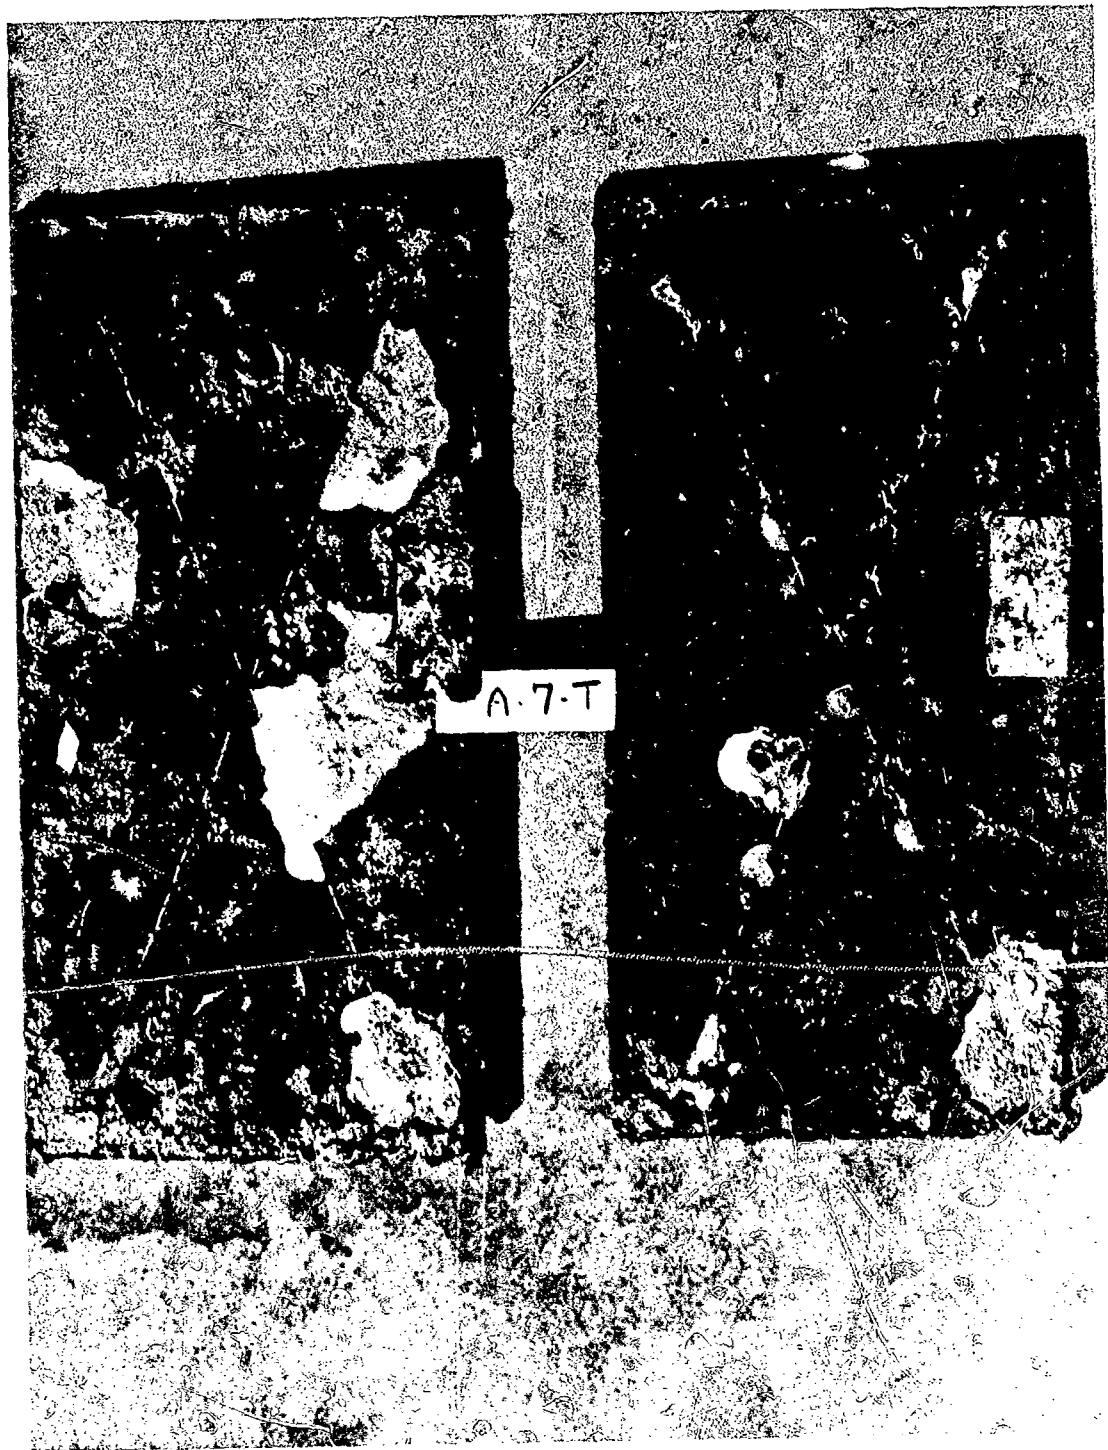
The remaining systems with the coal-tar epoxy topcoat, Epolux E-14, zinc rich epoxy System A-7-T (Figure 11), the sandblasted surface System A-9-T, the solvent washed surface System A-10-T, failed in less than

2 years of exposure because of loss of adhesion of the topcoat. The protection was slightly better over the sandblasted surface than over the solvent washed surface. Similarly, this topcoat was near failure when applied over the zinc-rich chlorinated rubber, System A-11-T, after 2 years of exposure in Port Hueneme Harbor.

Figure 11. Coal Tar Epoxy over a zinc rich epoxy, Epolux E-14, showing loss of adhesion to the primer after 3 years exposure.
